Asheville
Road Safety Audit 3 Report
US 25
(Merrimon Ave./Broadway/Biltmore Ave.)

November 4 - 5, 2015

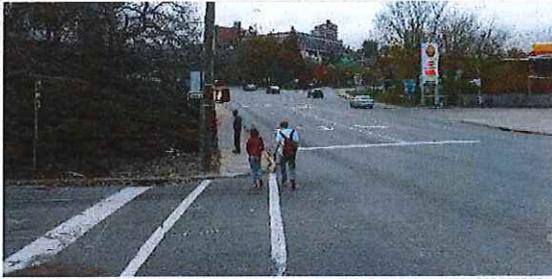
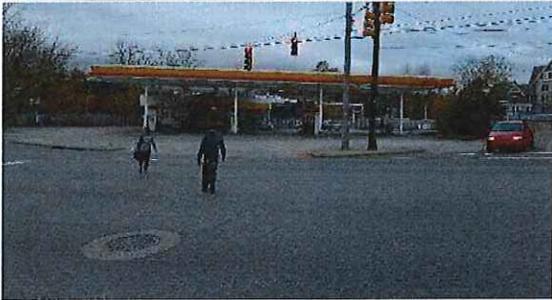
Pedestrians crossing against the signal and midblock

- Vehicles on both minor approaches block the crosswalk

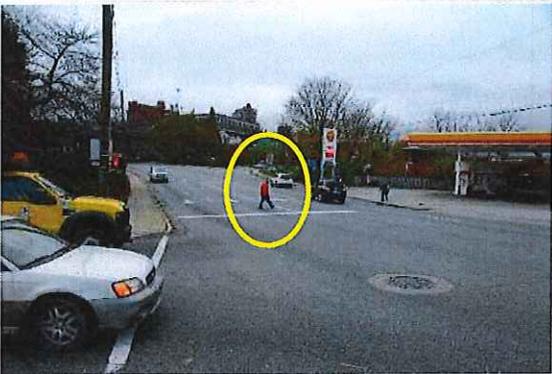
Pedestrian crossing travel lanes without a designated crosswalk and vehicles blocking crosswalk

- Police found that 85% of violations were from westbound right-turning vehicles not yielding to pedestrians
- East leg is coming off I-240 so drivers have not adjusted their behavior (e.g., higher speeds, not yielding to pedestrians) after entering the urban environment

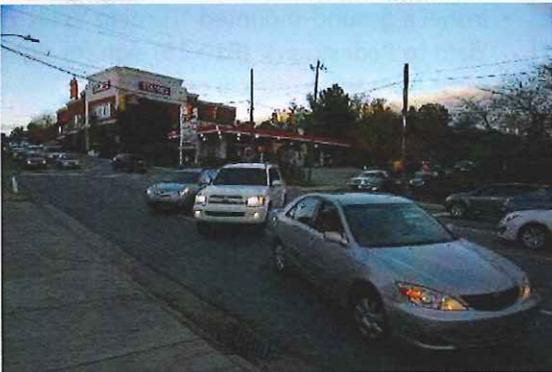
<p style="text-align: center;"><i>Vehicle stacking turning left from WB I-240 exit ramp onto SB US 25</i></p>	<p>Near Term</p> <ul style="list-style-type: none"> • Evaluate signal timing <p>Intermediate</p> <ul style="list-style-type: none"> • Consider flashing yellow arrow signal and protected phase for northbound left-turn movement <p>Long Term</p> <ul style="list-style-type: none"> • In NE quadrant, close driveway access points along Elm Street/I-240 WB exit ramp to eliminate cut-through maneuvers • Consider adding a lane to the westbound approach to allow dual left turns and shorten the queue on the ramp

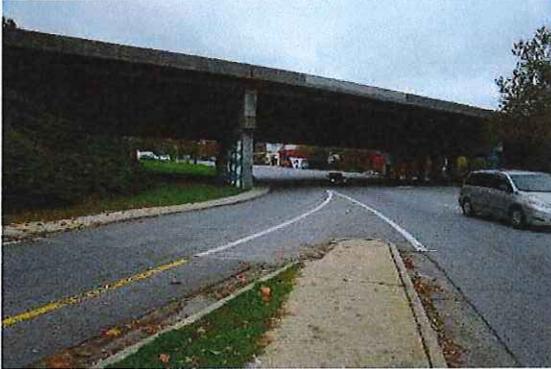
SB - The sidewalk ends, leaving pedestrians stranded

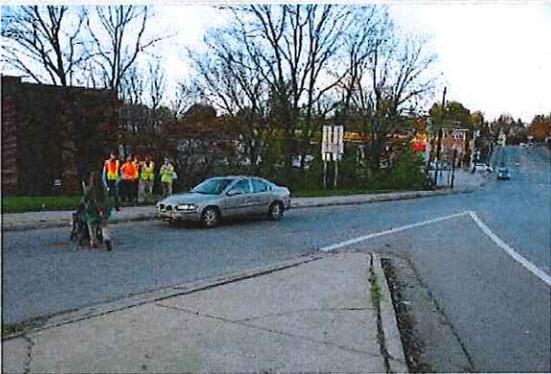
NB - The sidewalk ends, leaving pedestrians to cross at their own risk. This particular pedestrian was pushing a stroller and lived close to the intersection. She complained about not feeling safe when crossing the street.

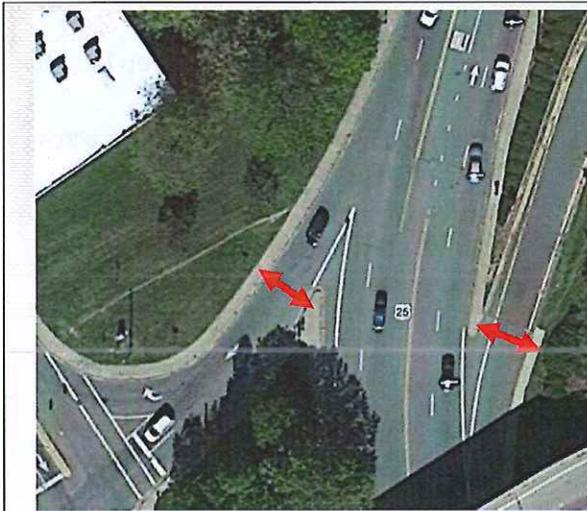
The red arrows indicate the approximate locations at which pedestrian crosswalks and supplemental devices may be considered, although sight distance needs to be verified; at left is the SB slip lane (left), and at right is the I-240 WB entrance loop

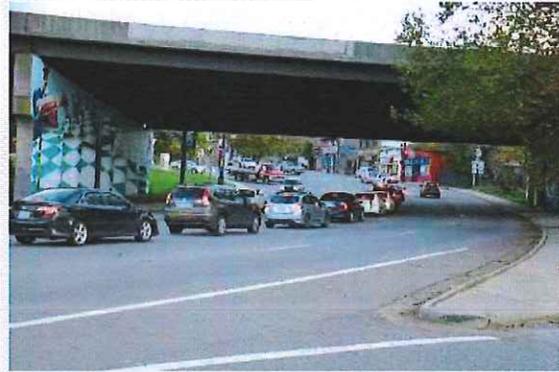
Vehicles queued to make southbound left onto I-240 E

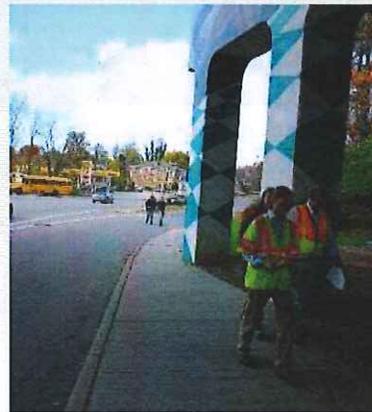
Bridge pillars obstructing visibility of pedestrians crossing the street

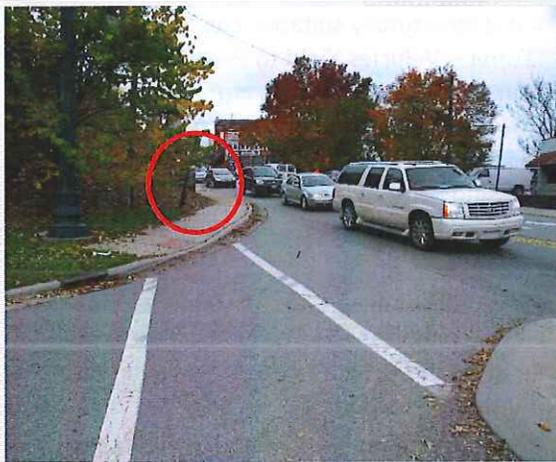
Looking south at crosswalk across NB right-turn onto I-240 EB ramp; existing retaining wall limits sight distance

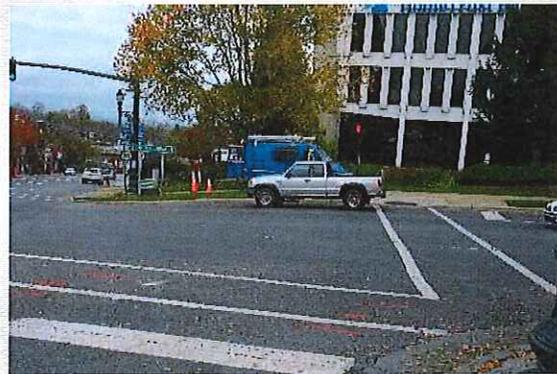
- Because the east leg's stop bar and crosswalk are located far from the intersection, right-turning vehicles consistently drive past the stop bar and crosswalk in order to gain better sight distance
- Push buttons on the southeast corner are not in an accessible location for pedestrians with mobility restrictions
- Crosswalk on south leg is not straight, which pedestrians with limited vision could find difficult to cross

Westbound vehicle making a right-turn driving past the stop bar and crosswalk on a red light

- At the WB approach: consider installing "Stop Here on Red," "No Right Turn on Red," 5-section signal head with right-turn overlap, or "No Turn on Red" blank-out sign
- Improve lighting at intersection, especially at crosswalks

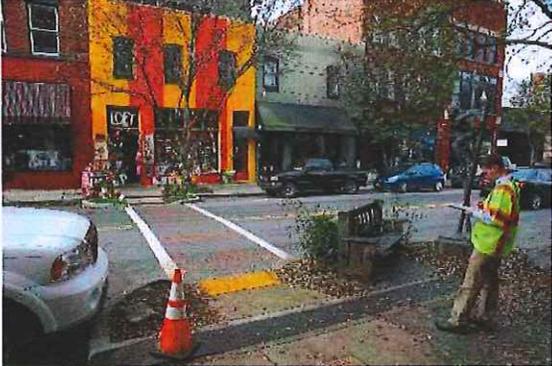
Issue Description	Suggested Action
<ul style="list-style-type: none"> Crosswalk is faded and difficult for drivers to see

<ul style="list-style-type: none"> Many motorists are not yielding to pedestrians Crossing was dark during night observations Cars parked adjacent to bulb-out obstructed sightlines between drivers and pedestrians 	<p>Near Term</p> <ul style="list-style-type: none"> Consider installing in-street yield to pedestrians sign and pedestrian warning sign on bulb-out Install high-visibility crosswalk Install yield line pavement markings in advance of the crosswalk Eliminate at least one parking space on each approach to the crossing and any unnecessary clutter on curb extension to increase sightlines between drivers and pedestrians; consider putting bicycle parking in that space instead

<p>Intermediate/Long Term</p> <ul style="list-style-type: none"> • Install overhead pedestrian warning signage, possibly with a flashing beacon • Install lighting
<p>7. Intersection of US 25/Walnut Street</p>	
<p>Issue Description</p>	<p>Suggested Action</p>
<ul style="list-style-type: none"> • Sun creates a glare in afternoon • Several left-turn collisions with pedestrians • Signal pole in northwest quadrant is located within the street with no protection or visual cue

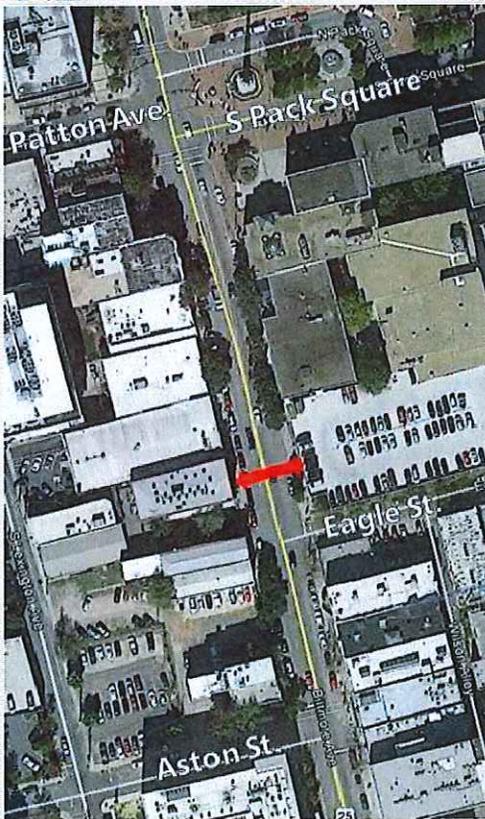
General vicinity of a potential marked crosswalk (north or south of deck driveway appear to be viable options)

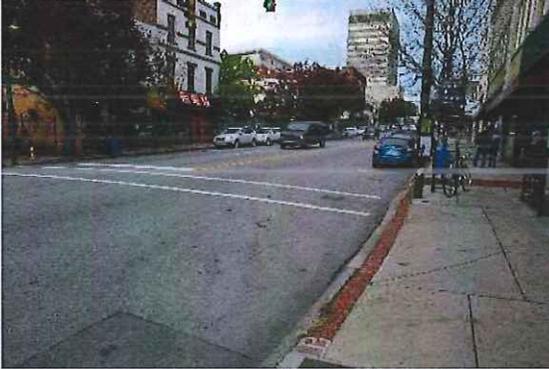
- Crosswalk does not align with curb ramp on north leg

- Remove and replace existing crosswalk pavement markings across north leg such that they align with curb ramp on east side
- Add crosswalk pavement markings on south leg
- Extend pedestrian walk interval to coincide with parallel vehicle green interval

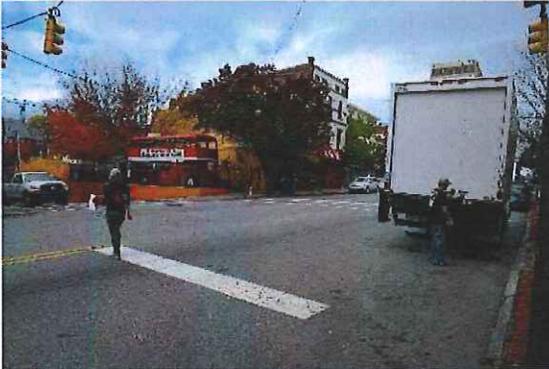
- No crosswalk on south leg

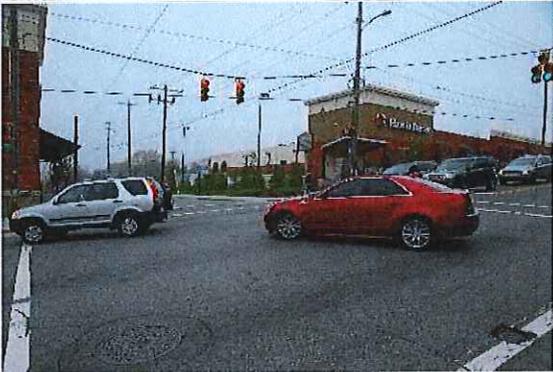
<p><i>The westbound left-turning vehicles running the red light</i></p> <ul style="list-style-type: none"> Push buttons on northwest corner are difficult to access because of the position of the signal controller cabinet and pole, especially if pedestrian has mobility restrictions Crest vertical curve limits sight distance for northbound left in permissive phase Right-turn only sign is posted at Broad Street; are drivers compliant? Sharrows on west leg of Chestnut Street are inappropriately placed in the middle of the road Bus stop (northwest corner) has an additional seating area that is disconnected from the sidewalk and is only accessible by stairs Multiple driveways between Orange and Chestnut and no turn lanes lead to queuing in through lanes

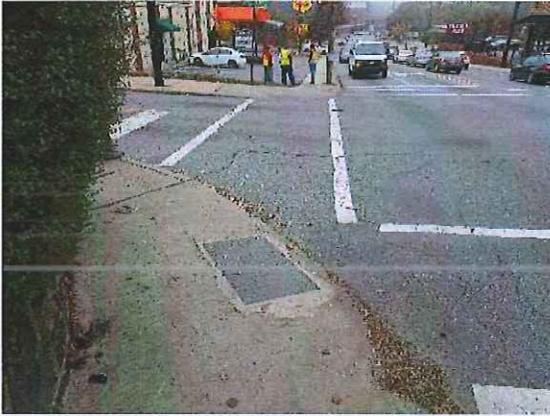
- Vegetation encroaches upon sidewalk in northeast corner

<ul style="list-style-type: none"> Trim or remove vegetation on northeast corner Add walk time to minor street to coincide with parallel green
