Asheville Road Safety Audit 2 Report Patton Avenue

October 28-29, 2015

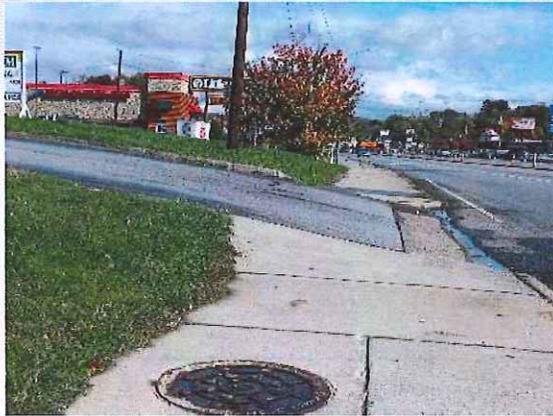
- Several driveways on north side create conflicts with pedestrians, and those within the westbound dual-right turn lane create a weaving movement to enter westbound through lane or U-turn at Leicester.
- Access to Little Caesar's is steep, which is an ADA issue

The steep grade in front of Little Caesar's.

- Redesign Little Caesar's driveway for ADA compliant cross-slope

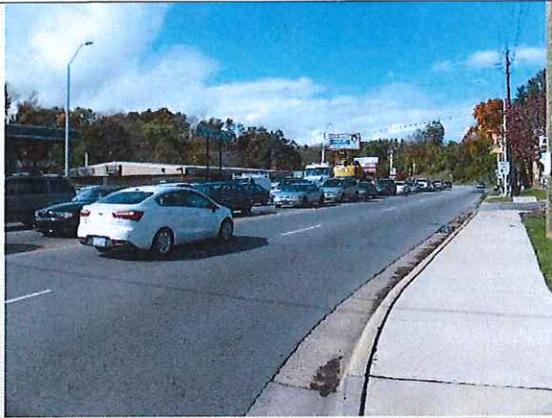
- Congestion on southbound approach
 - Dual left-turns have significant queueing
 - Utilization of left-turn lanes are inefficient (queue spreads)
 - Drivers use southbound two-way left-turn lane (TWLTL) to bypass queue
 - Drivers wait through multiple cycles during morning peak and other periods

Vehicles queuing to turn left from Leicester onto Patton Avenue

- Consider using outside lane as a shared thru/right/left to facilitate dual or triple left turn
- Continue ongoing enforcement of driver's use of the TWLTL on New Leicester to bypass queue

- Consider restriping TWLTL on New Leicester as a left-turn lane back to Druid Drive or just south of that, which will combat inefficient southbound left-turn lane utilization (queue spread)

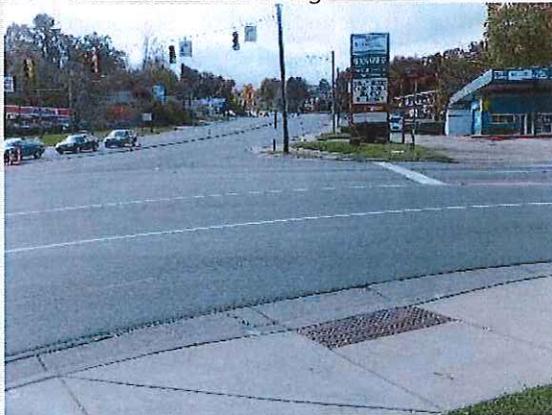
- Pedestrian Facilities
 - Lack of crosswalks and pedestrian signals
 - While there are plans for future crossings on 3 approaches, the RSA team noted the following concerns:
 - North crosswalk is conflicting with dual right-turn movement. Specific concerns include the high-speed turning movement and observed red-light-running
 - Lack of planned crossing on east leg
Limited access to bus stop on southeast corner
 - Lack of sidewalk along New Leicester

lack of crosswalks and pedestrian signals despite the curb ramp and truncated domes

- Install sidewalk on New Leicester to Ingles
- Install crosswalks and pedestrian signals pending installation of sidewalk around intersection
- Consider use of blank-out signs and red right-turn arrow on the westbound approach, along with placement of crosswalk on north approach, to ensure visibility of pedestrians and mitigate concerns with the conflicting right-turn movement
- Eliminate eastbound receiving lane to install pedestrian refuge and allow multi-stage crossing on the east leg
 - Any improvement should maintain corridor signal coordination and not exacerbate queue/congestion on the southbound approach

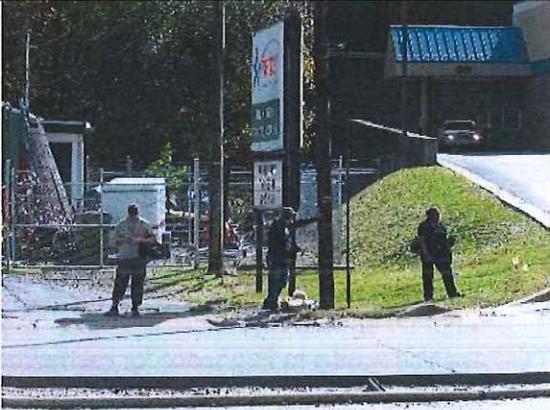
- Bus Stop
 - No access to bus stop on the south side from the north side of Patton Avenue
 - No shelter on the south side and north side

Pedestrians waiting at the bus stop on south side of Patton.

- Install bus shelter on the south side of Patton
- Install crosswalk from north side of Patton to south side. Also install a sidewalk along south side of Patton Avenue to access bus stop and other properties

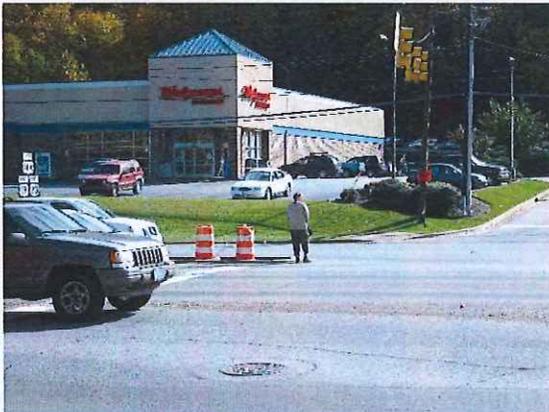
- Behavior
 - Red light running and rolling stops for westbound right-turn movement
 - Eastbound left turns were sneaking through on yellow and early red interval
 - Pedestrians crossing and standing in the median

Pedestrian waiting next to the median while crossing Patton despite the lack of pedestrian facilities

- Consider installing mini skip marks instead of solid white lines to delineate westbound dual right turn movement and discourage free-flow behavior during the red phase
- Enforce westbound right-turn red light runners
- Enforce eastbound left-turn red light runners

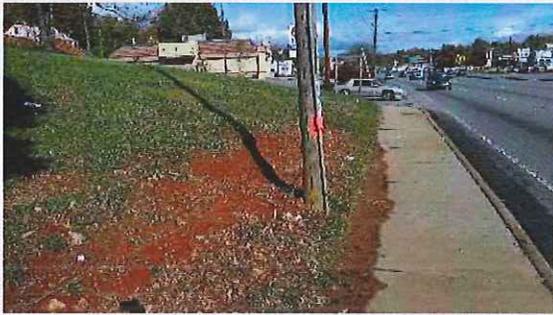
- Northwest corner of Louisiana, the drainage along Patton Avenue cuts into sidewalk

- Consider installation of crosswalk and pedestrian signal on the west approach
- Consider eliminating right-turn lane (or narrowing all lanes) on Louisiana to gain room for sidewalk. Note that it will be difficult to install sidewalk from Patton Avenue to K-Mart due to grade and existing buildings with limited offset to road
- Consider taking a lane of parking stalls in parking lot to install wide (or designated pedestrian area) sidewalk through the parking lot to K-Mart
- Consider moving bus stop on southeast corner further east to eliminate the potential to trap vehicles in the intersection that are following the bus
- Consider installing retaining walk and filling in hole in front of K-Mart
- Reconstruct sidewalk and drainage on the northwest corner

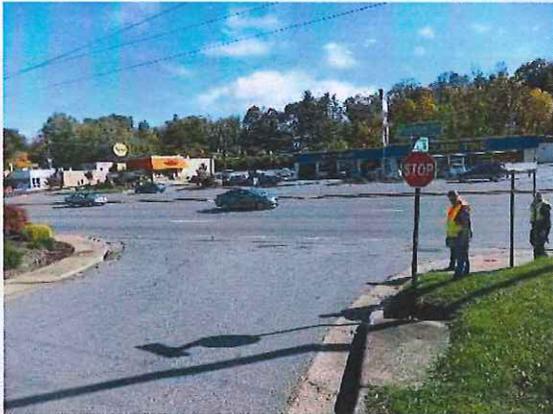
- Lack of wrong way or one-way signs to indicate presence of median
- Queue from Louisiana extends to Hawkins
- Sidewalk in front of Taco Bell narrows to 3 ft
- Curb ramps are angled into intersection, see corridor level for details

Lack of wrong way/one-way signs

- Install wrong way or one-way signage

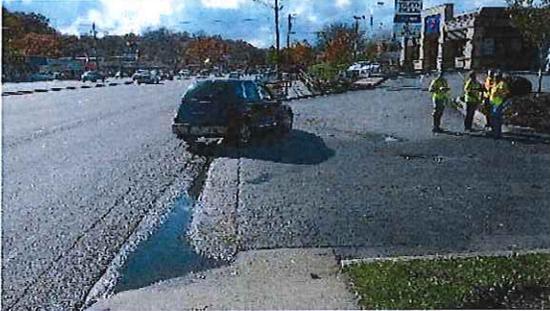
- The large width of the shared driveway of Taco Bell and Bank of America allows vehicles to enter at a high speed and the absence of pavement markings allows for inappropriate vehicle positioning when entering or exiting

The shared driveway of Taco Bell and Bank of America

- Potential for elimination or consolidation of Taco Bell driveways
- Potential to close western Bank of America driveway, which would add parking spaces
- Another option is to separate the Bank of America driveways

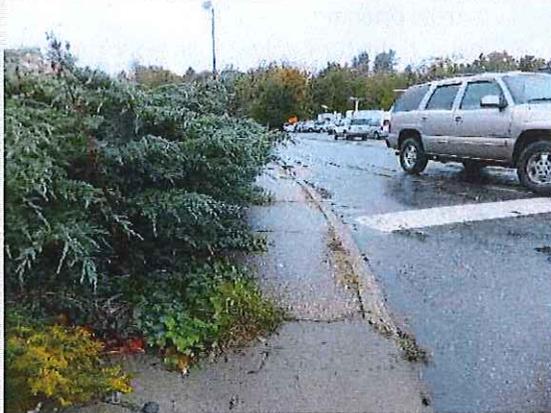
- Tree branches hanging over sidewalk on north side of Patton Avenue, see corridor level for details

- Install crosswalks and pedestrian signals (all approaches if feasible; otherwise on north, south, and west legs in the intermediate without moving stop bar and median island)
- Trim branches hanging over sidewalk

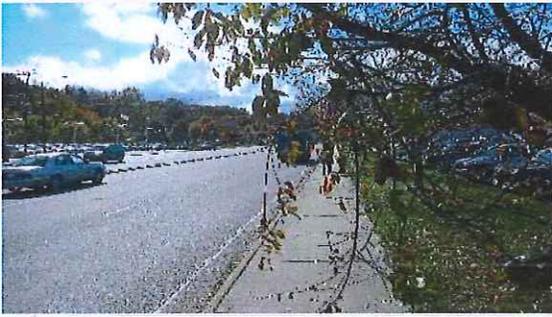
- Multiple driveways on the northeast and southeast corner, see corridor level for more details

- Consider extending sidewalk on Florida back to residential neighborhood
- Consolidate three drives on northeast corner to one or none and use access at signal for Florida
- Consolidate three driveways at Shell (southeast corner)

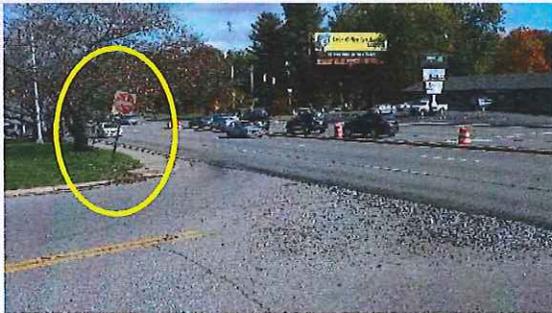
Debris in the roadway and the faded "Do Not Enter" sign

- Large wheel rut on Hazel Mill where debris was washed from
- Inappropriate "Do Not Enter" sign, which was also faded

- Clear rocks
- Fill in wheel rut
- Opportunity to install pork chop island to narrow opening
- Install right-turn only sign in pork chop or pavement marking
- Consider paving inside of curve to facilitate off-tracking
- Remove unnecessary sign and possibly replace with Wrong Way and/or One-Way signs
- Reorient curb ramps, see corridor level for more details
- Replace worm truncated domes at curb ramps
- Trim vegetation, see corridor level for more details

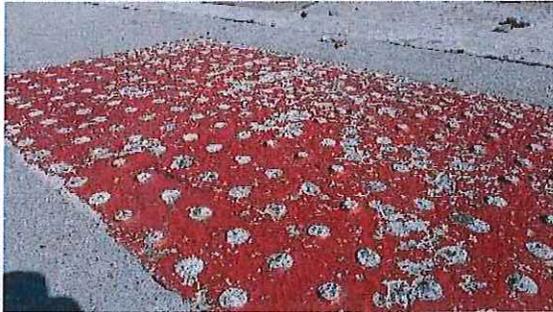
- Lack of one-way signs and wrong way signs
- Truncated domes are in poor condition (formed in concrete and worn down)

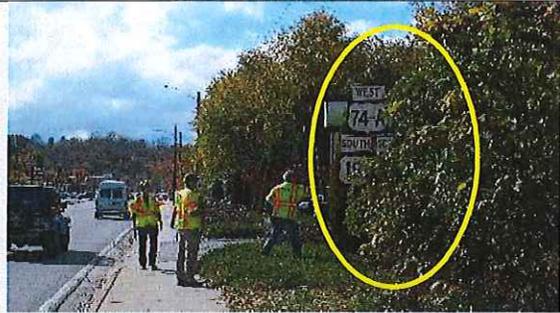
- Obstructed wayfinding sign (by the tree) and offset far from travel way
- 25 rear end crashes on Patton near Hazel Mill
