Asheville

Road Safety Audit 1 Report

Tunnel Road North

October 27-28, 2015

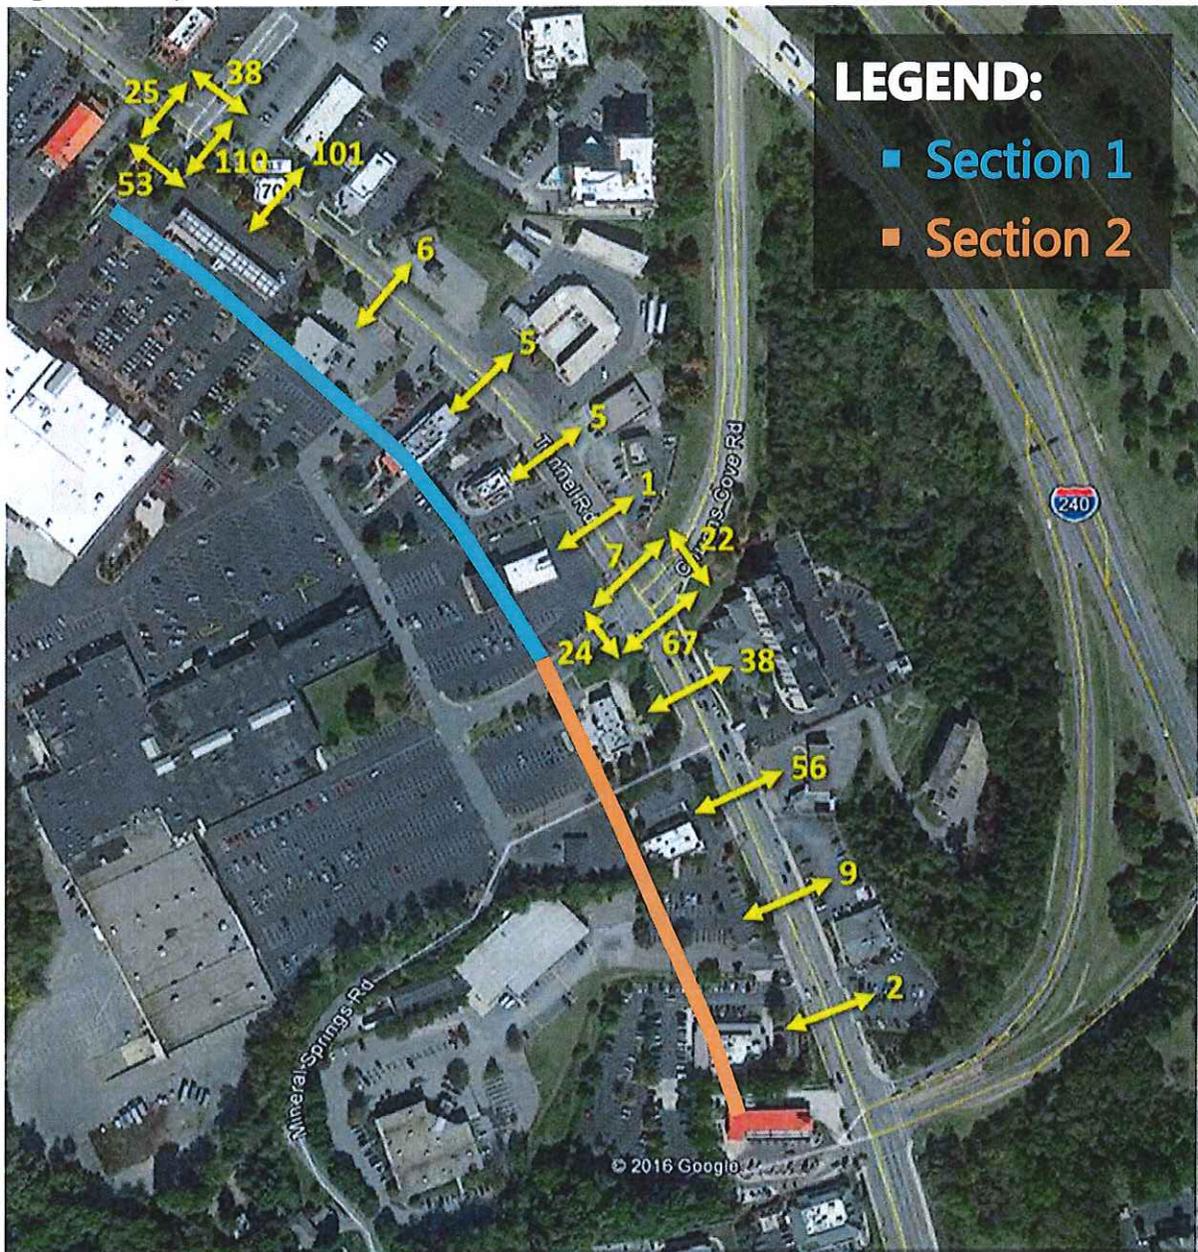
Figure 3. Number of pedestrian trips in the RSA study area (13-hour count).

The RSA team gathered available information on pedestrian activity from the City of Asheville and NCDOT to the best extent possible. To supplement available data and obtain a quantifiable volume for pedestrian activity, a new pedestrian count was conducted on two sections of Tunnel Road on Thursday, January 14, 2016. Although the schedule dictated an off-season count, the day selected was relatively warm with clear weather (high 58°F, 0.0 in precipitation) so pedestrians would be active. The 13-hour count began at 6:00 a.m. and ended at 7:00 p.m. The northern section (Section 1) was between the signal at the entrance to Ingles and Chunn's Cove Road. The southern section (Section 2) was between Chunn's Cove Road and the signal at the I-240 ramps. Within each section, pedestrian counts were grouped into individual zones, represented by the yellow arrows shown in Figure 3. Although the team observed a large

amount of pedestrian activity in January, it can be presumed that pedestrian volumes will be higher in the peak seasons.

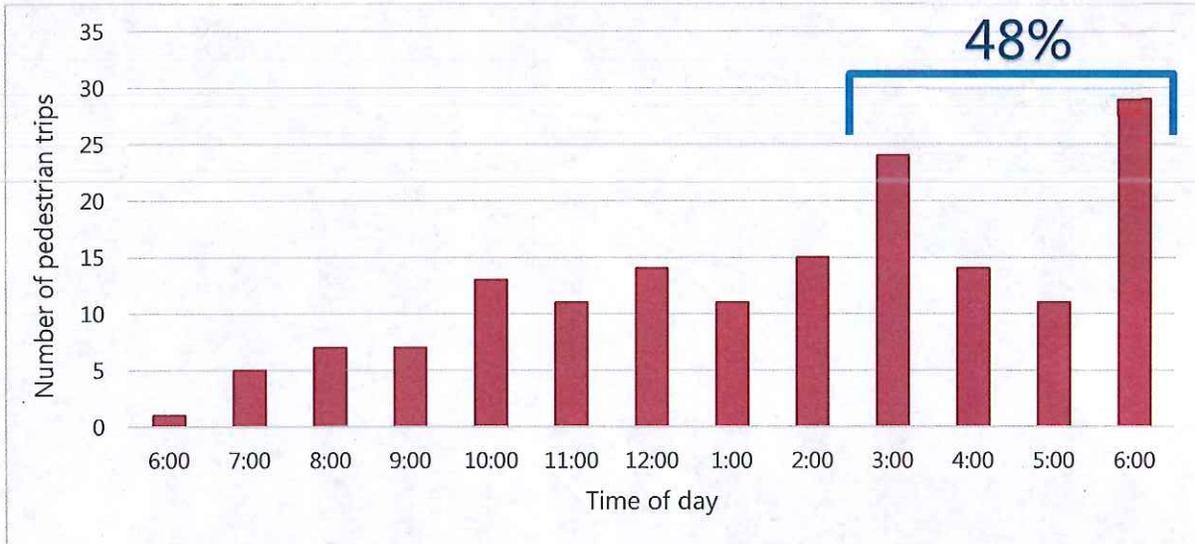
Figure 4. Pedestrian Trips on Section 2 of Tunnel Road.

destinations accounted for 59 percent of observed pedestrian trips in Section 1. As shown in Figure 4, the majority (73 percent) of pedestrians made trips in the afternoon (12 noon to 7:00 p.m.), with almost half (48 percent) of all pedestrian trips taking place in the evening (3:00 p.m. and 7:00 p.m.).

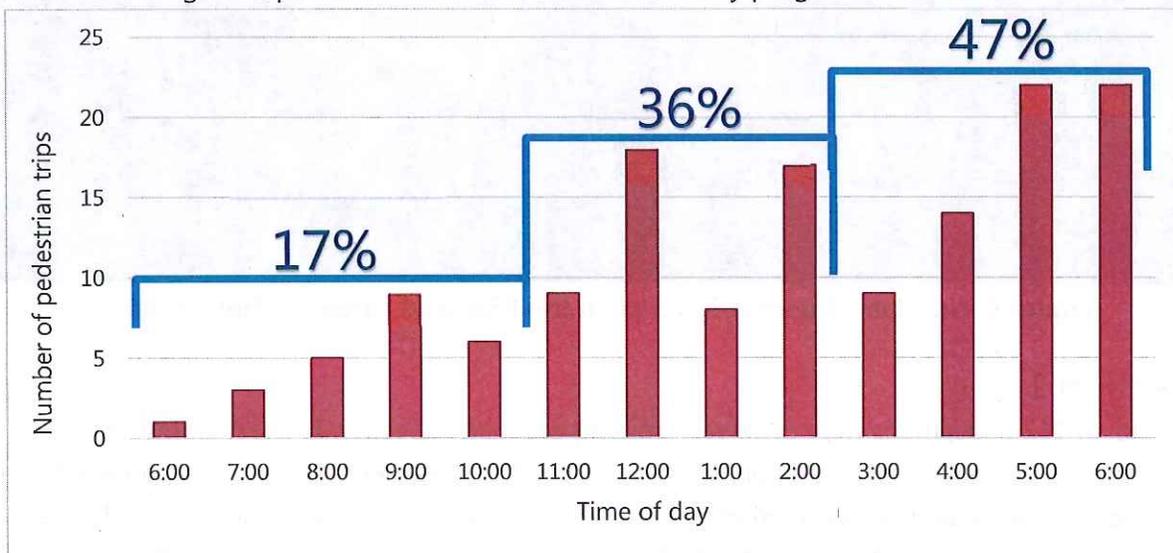
Figure 5. Pedestrian Trips on Section 2 of Tunnel Road.

A total of 143 pedestrians were observed crossing the road in Section 2. The majority of the pedestrians (56 percent) crossed the segment of Tunnel Road between Mineral Springs Road and just south of the Applebee's driveway. Approximately 80 percent of pedestrians performed midblock crossings and did not use the crosswalks at Chunns Cove Road and the I-240 ramps. As shown in Figure 5, pedestrian traffic increased as the day progressed.

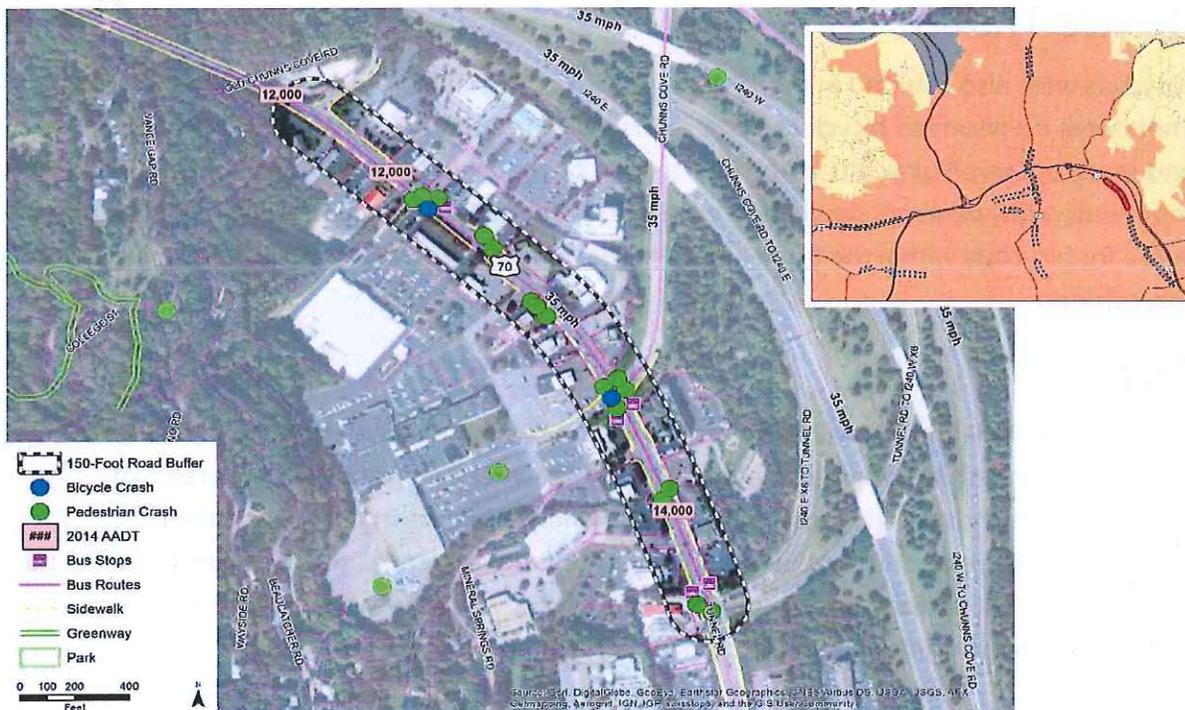
Figure 6. Location of pedestrian and bicycle crashes on Tunnel Road North.

In the past 10 years (2005–2014), 18 pedestrian crashes and 2 bicycle crashes were reported within the study corridor (see Figure 6. Location of pedestrian and bicycle crashes on Tunnel Road North.). These 20 reported crashes included one fatality, one A-injury, six B-injuries, eight C-injuries, three property damage only crashes, and one crash where the severity is unknown. Nine of the crashes (45 percent) occurred while it was dark, and three crashes (15 percent) occurred when the road was wet. The fatality in 2010 occurred while the roadway was dark and

wet. Additional details relating to these crashes are contained in the RSA Team packet provided in the Appendix.

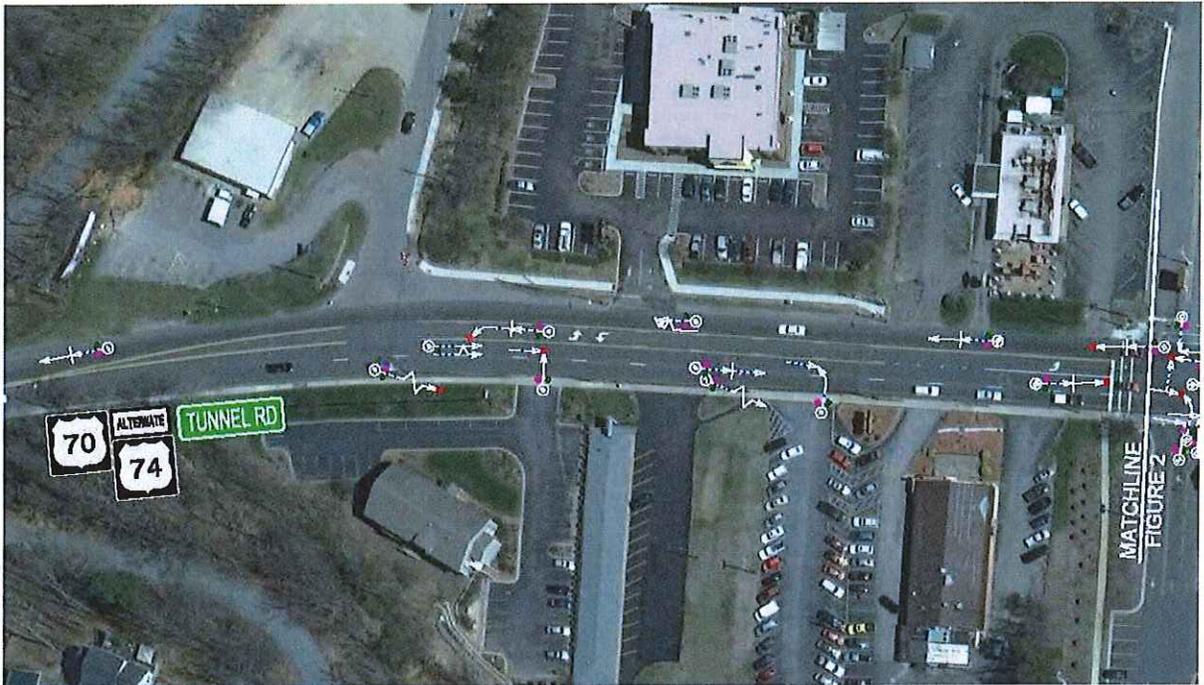
Figure 7. Collision Diagram from Old Chunn's Cove Road to the Ingles Driveway.

During the five-year analysis period (9/1/10 to 8/31/15), there were 169 reported vehicle crashes within the study area of Tunnel Road (mileposts 15.61 - 16.09). Figures 7 through 11 illustrate the location, speed, severity, crash type, and other characteristics of each crash in the past three years (9/1/12 to 8/31/15). The crash data reveals that rear end crashes are the most common crash type at 27 percent of the total crashes, followed by angle crashes at 25 percent, left-turn (same roadway) at 10 percent, and sideswipe (same direction) also at 10 percent. Table 1 shows the severity and crash type of all collisions in the five-year study period. Rear end and angle crashes account for 51 percent of the total number of crashes.

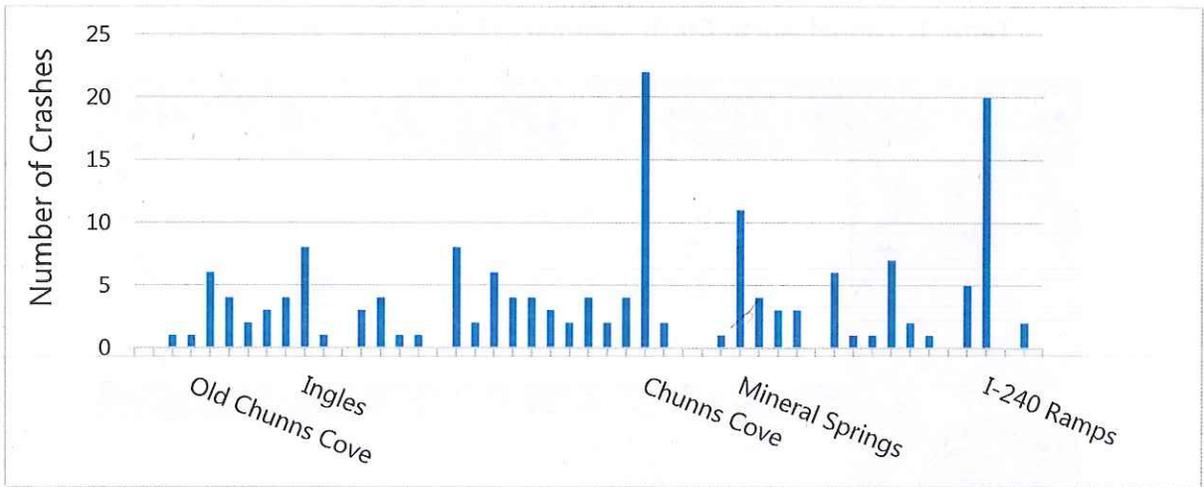
Figure 11. Histogram of vehicular crashes along Tunnel Road, Sept 2010 through Aug 2015.

Figure 11 depicts the distribution of crashes along the study area by 1/100th of a mile (52.8 feet) beginning at milepost 15.61 (just west of Old Chunns Cove Road) and ending at milepost 16.09 (just east of the I-240 ramps). The key intersections are labeled in Figure 11, which shows that 83 crashes (49 percent) occurred within the functional area (0.03 mile or 158 ft.) of the three signalized intersections (Ingles, Chunns Cove Road, and I-240 ramps); however, collisions occurred between signalized intersections as well.

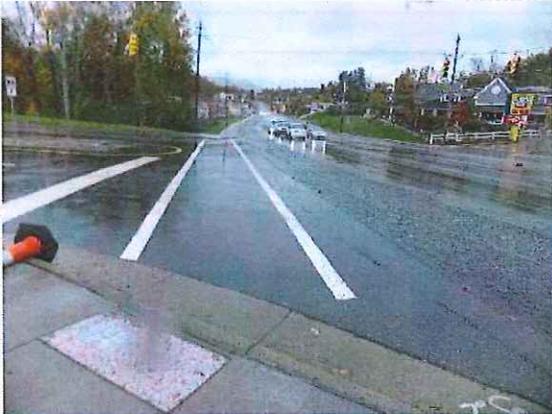
1. Crossings	
Issue Description	Suggested Action
<ul style="list-style-type: none"> • Wide crossing distance <ul style="list-style-type: none"> - Tunnel Road is a five-lane cross-section, which results in a long crossing distance (approximately 55 feet at its widest) - Large corner radius increases crossing distance and allows vehicles to turn at higher speeds at the intersections of Tunnel Road with the I-240 ramps and Chunns Cove Road (NE and SE). - Excess capacity on minor roads (separate left-turn lane for split phase) increases the crossing distance for pedestrians • Lack of median refuge islands <ul style="list-style-type: none"> - I-240 ramp (and other side roads) 	<p>Near Term</p> <ul style="list-style-type: none"> • Consider installing high visibility pavement markings at signalized intersections when resurfaced • Remove antiquated truncated domes and replace with standard ADA-compliant domes <p>Intermediate</p> <ul style="list-style-type: none"> • Add pedestrian phase to westbound approach at I-240 interchange and consider extending the median to install a pedestrian refuge island [Note the RSA team observed large trucks turning left from Tunnel Road onto the I-240 ramp and the extension of the median should not create issues with turning radius] <p>Long Term</p> <ul style="list-style-type: none"> • Consider consolidating eastbound approach turn lanes at the I-240 ramps and reducing southeast and northeast corner radii to narrow crossing distance and to reduce turning speeds • At Chunns Cove Road, consider reducing the radius of the southeast corner • The team decided that a more detailed evaluation of midblock crossing opportunities should be conducted at the conclusion of the RSA. This included the collection of new pedestrian data along the corridor (Figure 3) and review of applicable NCDOT/FHWA/ITE guidance concerning midblock crossings. Below are some noted findings from this evaluation: <ul style="list-style-type: none"> - According to the, North Carolina Pedestrian Crossing Guidance midblock crossings should be located at least 400 ft. from signalized intersections. The space between the closest Chunns Cove Road and I-240

</div> <ul style="list-style-type: none"> - Open median/two-way left-turn lane along Tunnel Road • Lack of crosswalk markings, particularly at Ingles intersection • Narrow truncated domes • At several crossings, the orientation of curb ramps and truncated domes are not properly aligned, therefore users (especially visually impaired pedestrians) could be misled into

the intersection rather than into the crosswalk

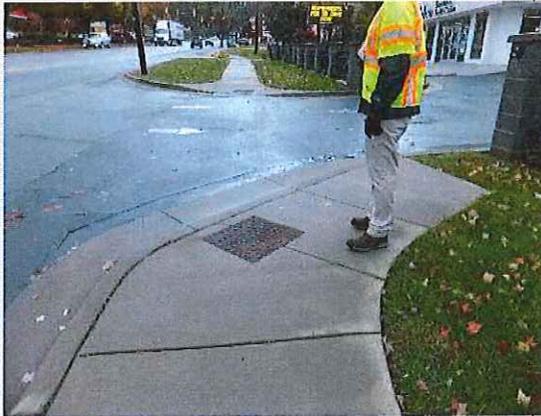
Truncated dome plate is not centered in the curb ramp, and the ramp and dome direct pedestrians into the center of the intersection

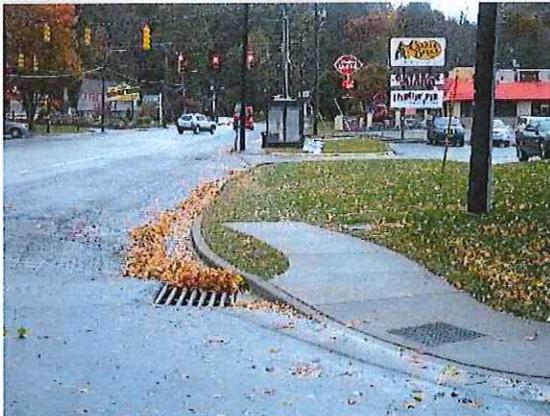
- Gaps in the sidewalk network, mainly the east side of Tunnel Road, north of Chunns Cove Road

- Install pedestrian signals at the I-240 intersection
- Consider community development building grant (CDBG) opportunities to fill-in gaps in the pedestrian network
- Look into local ordinances to pay for sidewalk installation/repair/redesign
 - Sidewalk should continue across driveways rather than driveways continuing across sidewalks
 - Minimum of 5-ft widths per Table 3-19 of the City of Asheville Standard Specifications and Details Manual
 - Eliminate the buffer strip on the west side of Tunnel Road (near the tunnel) and infill with sidewalk
 - Eliminate obstructions in sidewalk
 - Ensure accessibility to bus stops
 - Consider landing space for kneeling buses
- Install curb to separate the sidewalk and travel way on the west side of Tunnel Road (near the tunnel)

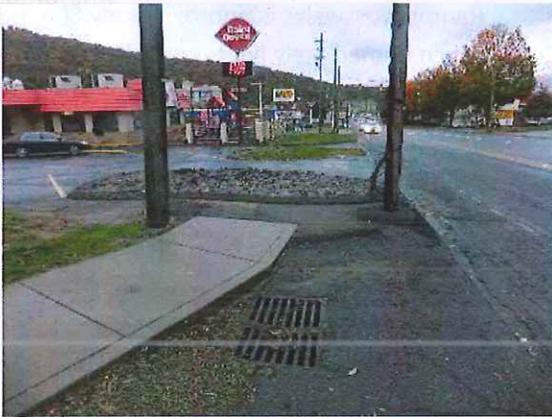
Gaps in the sidewalk network

- Fill-in gaps and enhance sidewalk network as redevelopment occurs. For example, sidewalks should continue across driveways rather than driveways continuing across sidewalks, widen sidewalks to 6 ft, and eliminate obstructions in sidewalk.

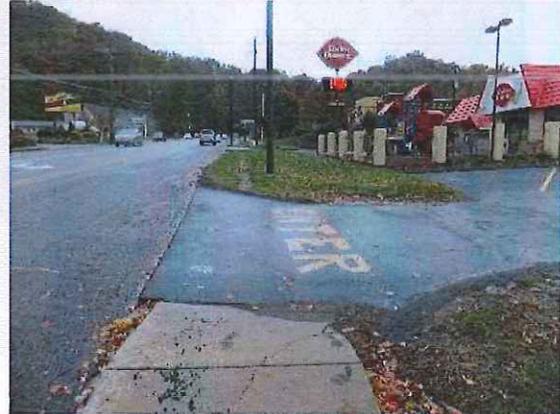
Example of a sidewalk stopping at driveway, instead of continuing across driveways

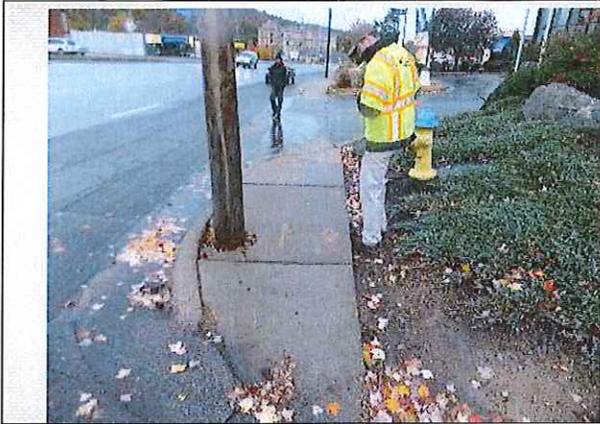
3. Driveway Conflicts / Access Management	
Issue Description	Suggested Action
<ul style="list-style-type: none"> The large number of closely spaced openings leads to a higher chance of collisions between turning vehicles and through vehicles, bicyclists, and pedestrians. Some openings are wider than needed. These large distances increase pedestrian exposure to vehicles and allow vehicles to enter and exit driveways at higher speeds. 	<p>Near Term</p> <ul style="list-style-type: none"> Consider targeted signing to restrict left-turn movements at driveways that are not currently restricted (Ingles Gas Express Exit and Mineral Springs Road are currently restricted) Start conversations with business owners to identify opportunities to consolidate, share, and narrow driveway openings <ul style="list-style-type: none"> - For shared locations, consider shared signing in splitter island - Check access management manual for preferred widths - Prioritize removal of driveways within functional area of intersection Review State and local access policies <ul style="list-style-type: none"> - Consider opportunities to strengthen local ordinances to support decisions

- Close, consolidate, narrow driveways as redevelopment occurs
 - Prioritize removal of driveways within functional area of intersection
- A raised median is a standard measure for addressing driveway conflicts; however, the team decided not to recommend a median at this time for the following reasons:
 - Difficult to accommodate u-turns
 - With I-240 serving as a parallel route for through traffic, Tunnel Road can accommodate a high level of access
 - Driveway crash patterns may not be substantial enough to warrant high costs and impacts associated with a median
 - Pushback from businesses
- An alternative to a median is for better connectivity between businesses
 - The grade and terrain will make it difficult to connect several lots

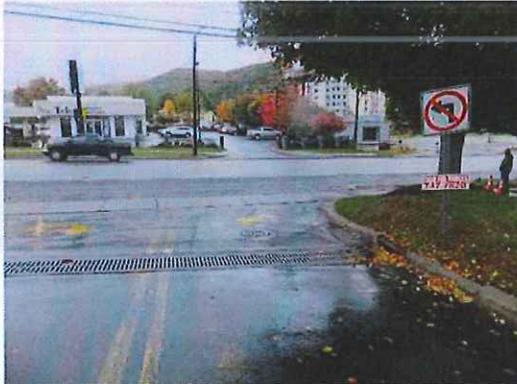
- Lack of physical elements to prohibit left-turns at locations with left-turn restrictions. Existing signage and pavement markings are not effective at these locations.

The RSA team observed that signage and pavement markings are not effective in preventing vehicles from turning left. This location is at the exit of the Ingles gas station.

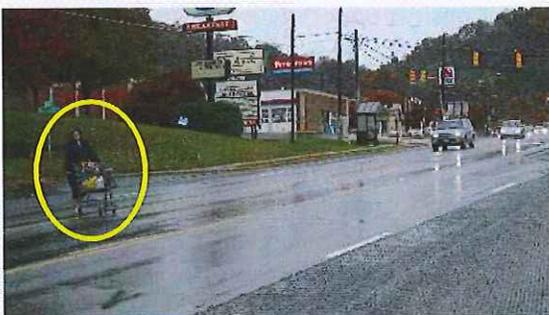
- There are several points of interest on both sides of Tunnel Road, which attract midblock crossings. The only crosswalks are located at signalized intersections, which are spaced approximately 1,000 ft apart. So many pedestrians are choosing to cross midblock rather than walk to the nearest crosswalk.

- The RSA team observed several pedestrians crossing against the signal. This was a particular

concern for pedestrians alighting the bus at bus stops.

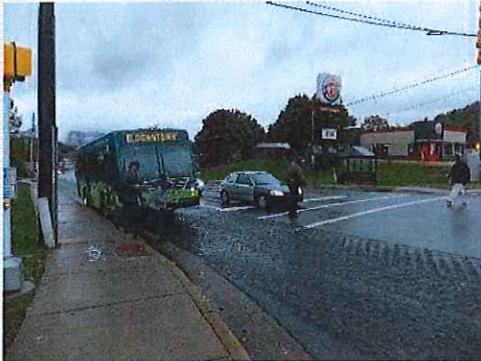
Pedestrians crossed Tunnel Road at Chunn's Cove Road immediately after alighting the bus without waiting for the pedestrian signal. In this instance, vehicles with a green light on Tunnel Road had to yield in the road for the pedestrians

- Consider opportunities to include audible safety messages on buses and with signs/posters inside the buses
- Consider targeted enforcement for vehicles passing stopped bus using left-turn lane at the Ingles intersection
- Install additional signing/markings to alert drivers to the lane drop and which lane drops north of the Chunn's Cove Road intersection

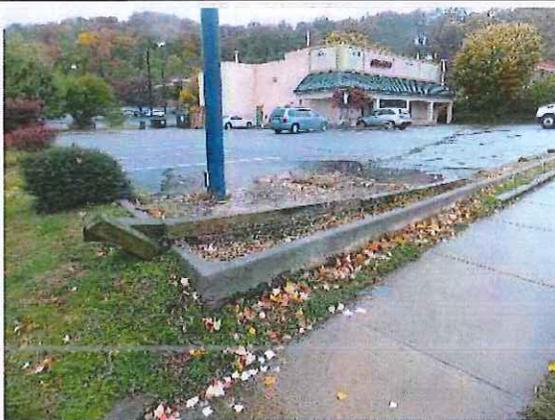
5. Maintenance and Drainage	
Issue Description	Suggested Action
<ul style="list-style-type: none"> • Drainage issues <ul style="list-style-type: none"> - Lack of storage ponds and best management practices (BMPs) for storm water management - Large impervious areas - Water ponding in parking areas and flowing onto sidewalks - Water sheeting across driveways onto sidewalks - The bars on drainage grates are spaced too far apart so that bicycle tires could fall through 	<p>Near Term</p> <ul style="list-style-type: none"> • Replace drainage grates with bicycle-friendly grates • Alert city to maintenance issues • Review City storm water ordinances (Phase 2 or MS4) <p>Intermediate</p> <ul style="list-style-type: none"> • Install curb near tunnel to separate sidewalk and roadway

Water has gathered in the corner of the parking lot and has leached through the ground flowing onto the sidewalk

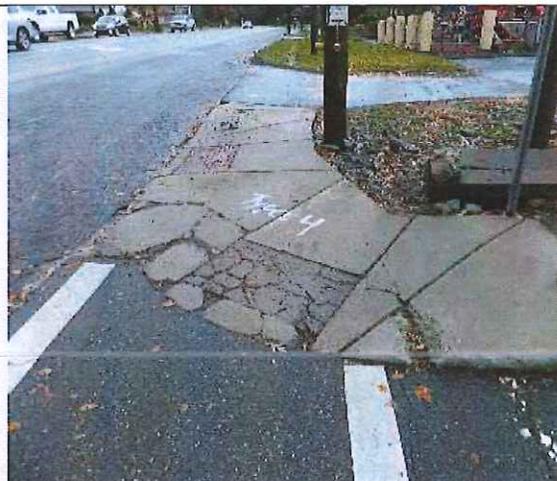
- Sidewalk disrepair
 - Tripping hazards (settling)
 - Broken sidewalks
 - Drop-offs adjacent to sidewalk
 - Near tunnel there is exposed rock and no sidewalk to act as a buffer between pedestrians and vehicles
- Lack of curb in some locations
 - West side of Tunnel Road (near tunnel)

Example of sidewalk disrepair

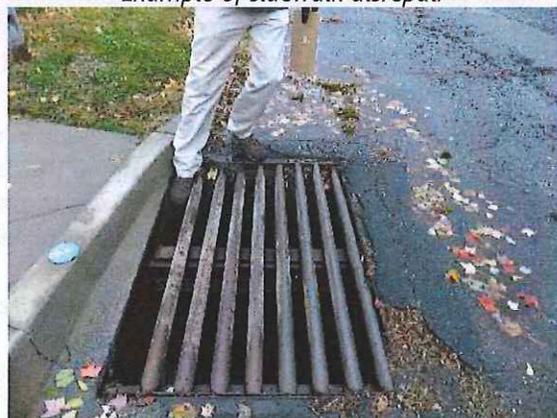
This drainage grate is located just south of the Telco Community Credit Union, on the north side of Tunnel Road

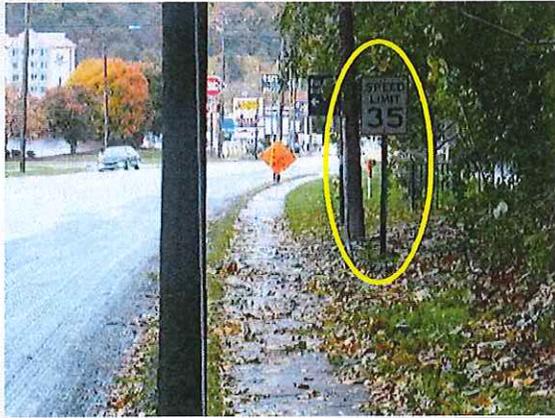
6. Signals, Signs, and Markings	
Issue Description	Suggested Action
<ul style="list-style-type: none"> • Southbound protected-only left-turn phase at I-240 intersection may be unnecessary • Lack of high visibility pedestrian markings • Inconspicuous speed limit sign (southbound exiting tunnel) [Note that most RSA team members agreed that speed limit signs are a good reminder, but at least one member indicated that they may not be necessary given the 35 mph statutory speed.] 	<p>Near Term</p> <ul style="list-style-type: none"> • Consider replacing fully protected southbound left-turn signal at I-240 intersection with protected/permitted movement and Flashing Yellow Arrow (FYA) <ul style="list-style-type: none"> - Look at conflicting movements and monitor crashes after installation to see if left-turn crashes increase - In northbound direction (for left-turn into car wash), consider 3-section FYA to allow lag in southbound direction • Install high-visibility crosswalks on all approaches of signalized intersections (piano key style)

- Historical Marker sign at Chunn's Cove Road is obstructing/cluttering other information (important message is the lane drop)

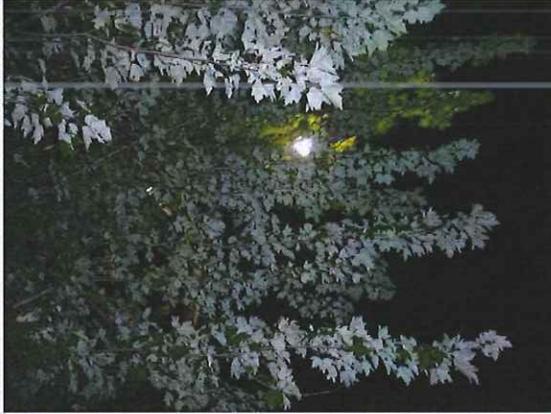
- Street light near Blue Ridge Motor Lodge is out
- Trees in front of Applebee's and near tunnel (west side) cast shadows below light

- Dark spot on east side of Tunnel Road near tunnel (where sidewalk exits tunnel)
- Dark spot at Ingles intersection (good lighting at other signals)

- Replace light at Blue Ridge Motor Lodge
- Remove branches or trees that are blocking street lights

- Add lighting near tunnel and the signalized intersection at Ingles

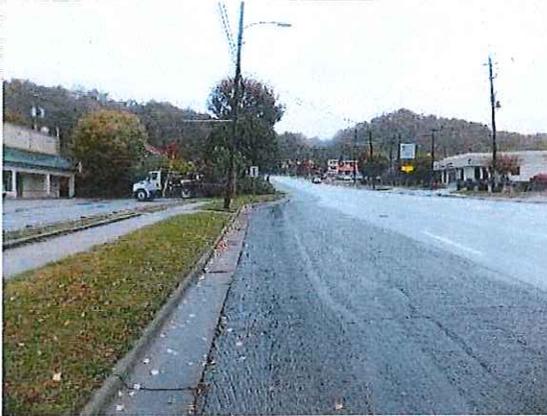
- Unusual widening near McDonalds on west side of Tunnel Road south of Ingles intersection, likely part of an old bus turnout

- Reclaim unused roadway space near McDonalds to allocate for sidewalk/bus stop accommodations
- Widening the tunnel is cost-prohibitive; however, the team discussed reallocating sidewalk and travel lane widths within the tunnel, but decided not to recommend any changes. Reducing lane widths to widen the sidewalk was not advised since it could result in increased vehicle or bicycle crashes. In addition, shifting the lanes is not feasible due to clearance height within the tunnel. Due to the current tunnel width and its difficulty to safely accommodate bicyclists, NCDOT has expressed concerns with designs that attract bicyclists to this location.

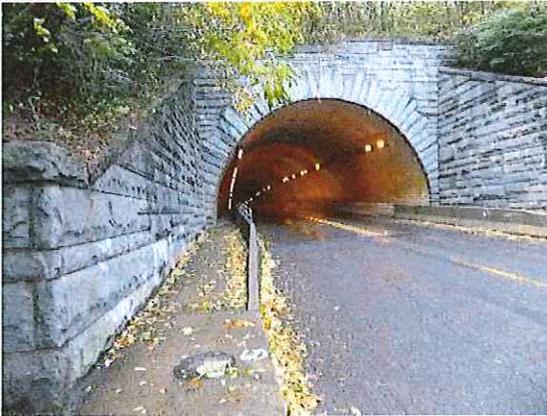
- Tunnel
 - Narrow pedestrian accommodations
 - Narrow bicycle accommodations
