Asheville
Road Safety Audit 3 Report
US 25
(Merrimon Ave./Broadway/Biltmore Ave.)

November 4 - 5, 2015

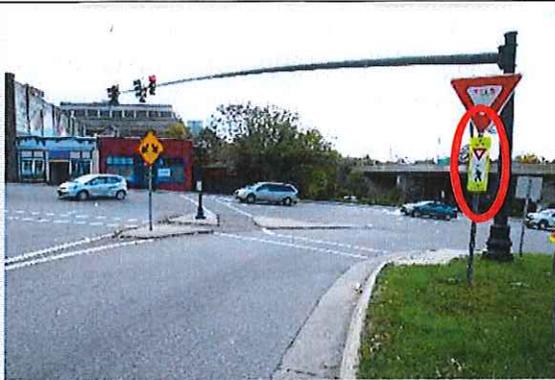
- Five (5) collisions between southbound, left-turning vehicles and northbound bicyclists out of the 10 bicycle crashes in the RSA study area (2005-2014); this is possible because southbound left turns operate under permissive phasing

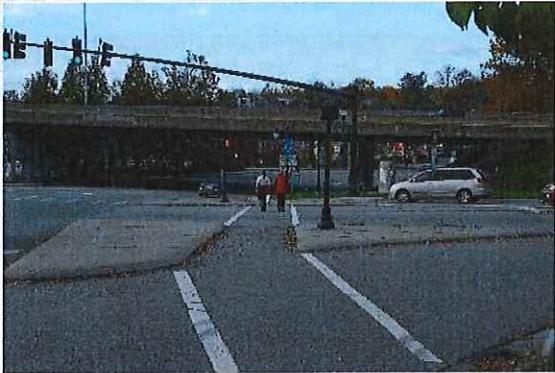
- Insufficient lighting of the pedestrian crossings
- Absence of 20 mph speed limit sign southbound before entering downtown
- Existing retaining wall and vegetation limit sight distance for NB drivers approaching the right turn onto I-240 EB ramp, which is a yield-controlled movement

- If it is structurally suitable, consider installing a "Turning Vehicles Yield to Pedestrians" (R10-15) sign on the existing mast arm for right turns from northbound US 25 onto the I-240 EB ramps to increase awareness of potential pedestrian crossings at that location

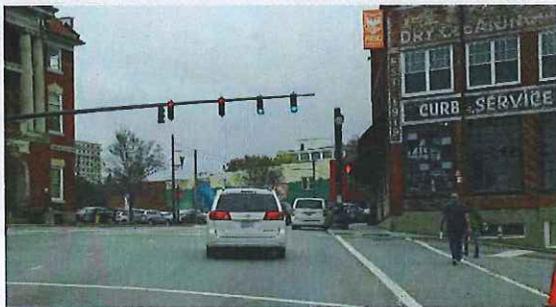
- Under current lane configuration, southbound through lane has to shift one lane to the left within the intersection because of on-street parking that begins at the far side without warning

- Pedestrians were observed crossing midblock and in front of the bus after off-loading on the north leg of intersection

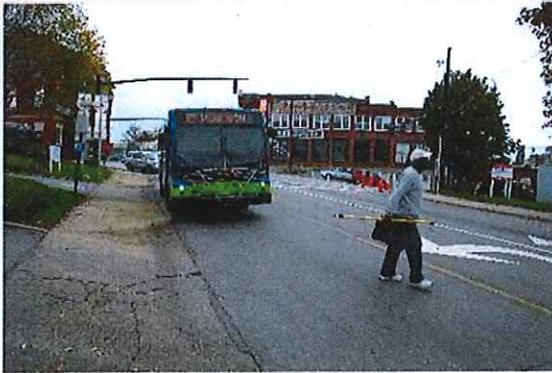
- Because the east leg's stop bar and crosswalk are located far from the intersection, right-turning vehicles consistently drive past the stop bar and crosswalk in order to gain better sight distance
- Push buttons on the southeast corner are not in an accessible location for pedestrians with mobility restrictions
- Crosswalk on south leg is not straight, which pedestrians with limited vision could find difficult to cross

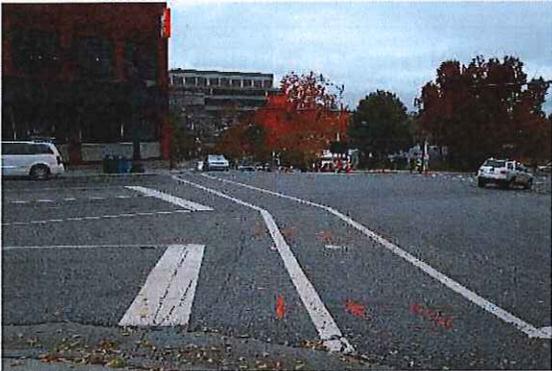
- Multiple drivers were observed to treat the northbound right-turn lane like a free-flow turn, as they failed to stop when their signal indication was red
- Intersection was not adequately lit during the night observation
- The crosswalk on the west leg is long and skewed

- Based on the RSA observations and subsequent capacity analyses, the team recommends that NCDOT consider reconfiguring some of the through and right-turn lanes to shorten pedestrian crossing distances.
- Consider converting the northbound left-turn lane and southbound inside left-turn to a second northbound through lane via restriping. With these improvements in place, pedestrian crossing exposure is reduced on

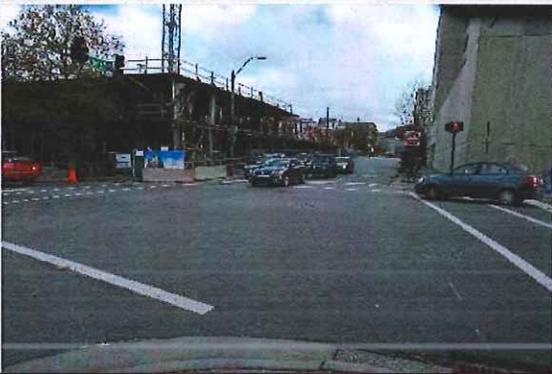
<p>8. Intersection of US 25/College Street</p>	
<p>Issue Description</p>	<p>Suggested Action</p>
<ul style="list-style-type: none"> • Positive: three-second leading pedestrian interval • Northbound left-turn queueing is an issue because of the close proximity to the intersection of Patton/Pack Square • A positive feature is the post-mounted "No Right Turn" sign for northbound drivers, but there is no signing alerting drivers that southbound left turns are prohibited • Pedestrian signal pole is unstable and will sway at the touch 	<p>Near Term</p> <ul style="list-style-type: none"> • If it is structurally suitable, install "No Right Turn" sign on mast arm of northbound approach • If it is structurally suitable, install "No Left Turn" sign on mast arm of southbound approach • Stabilize pedestrian signal pole

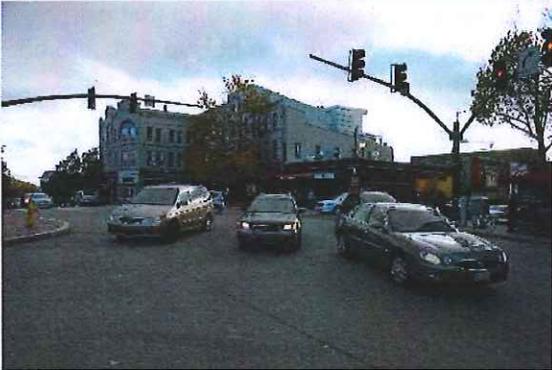
- Queues forming from eastbound left turns because of close proximity to College Street intersection

- Short pedestrian walk time across east leg is resulting in pedestrians frequently crossing on "don't walk" phase because parallel vehicular phase is still green
- Lane configuration changes south of College Street
- Conflicts with eastbound left-turns and pedestrians

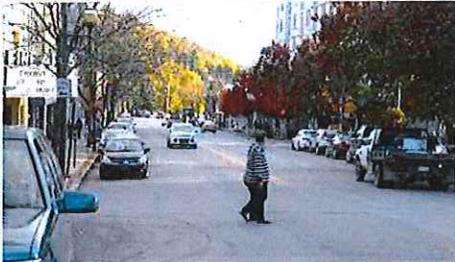
- The many shops and restaurants and the numerous parking accommodations via on-street and deck parking generate many pedestrians in this segment. Over 800 pedestrians were counted crossing from 6 AM – 7 PM at midblock locations between the signalized crosswalks at S. Pack Square and Aston Street, which are separated by 600 ft. The majority of crossings were made at sporadic locations between the crosswalks, many originating between parked cars.

General vicinity of a potential marked crosswalk (north or south of deck driveway appear to be viable options)

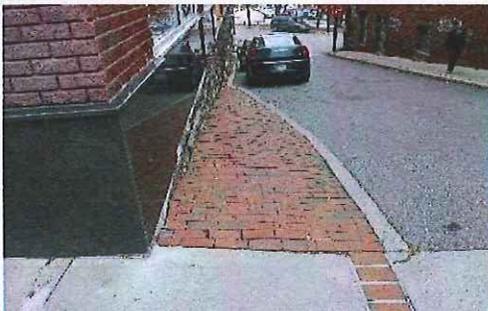
- Brick sidewalk along left side of Sycamore Street tapers and ends in the street

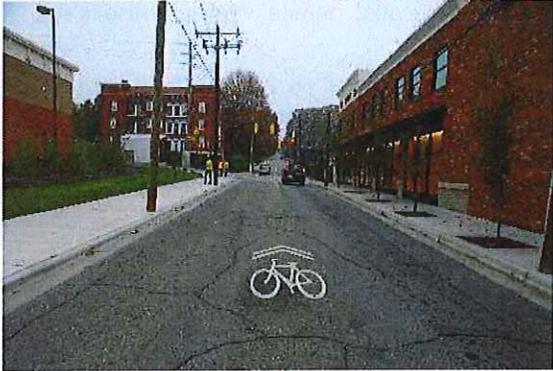
<p><i>The westbound left-turning vehicles running the red light</i></p> <ul style="list-style-type: none"> Push buttons on northwest corner are difficult to access because of the position of the signal controller cabinet and pole, especially if pedestrian has mobility restrictions Crest vertical curve limits sight distance for northbound left in permissive phase Right-turn only sign is posted at Broad Street; are drivers compliant? Sharrows on west leg of Chestnut Street are inappropriately placed in the middle of the road Bus stop (northwest corner) has an additional seating area that is disconnected from the sidewalk and is only accessible by stairs Multiple driveways between Orange and Chestnut and no turn lanes lead to queuing in through lanes

<ul style="list-style-type: none"> Connect seating area at the bus stop on northwest corner to sidewalk
