Asheville Road Safety Audit 2 Report Patton Avenue

October 28-29, 2015

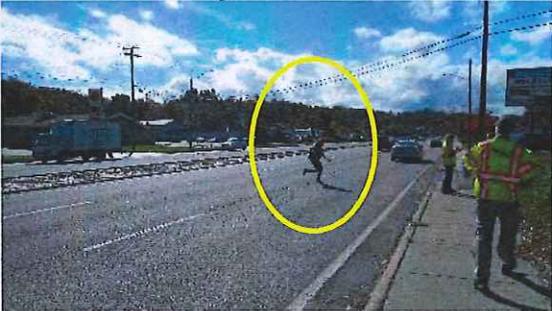
1. Corridor-wide	
Issue Description	Suggested Action
<ul style="list-style-type: none"> Multiple parcels have several driveways in close proximity, which may be consolidated Pedestrians crossing midblock

<p>Intermediate</p> <ul style="list-style-type: none"> Consider installing positive barrier to discourage midblock pedestrian crossings. The impacts for emergency response should be considered for this countermeasure Install sidewalks on the south side of Patton

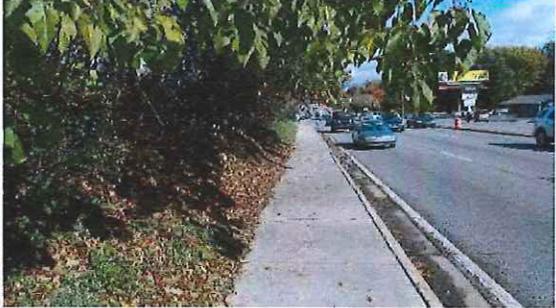
<ul style="list-style-type: none"> Lack of sidewalks and connectivity on the south side of Patton Tow truck rotation (rotation-based response instead of proximity-based). This results in long delays, particularly during rush hour East end of corridor is relatively dark (from Acton Chiropractic to Regent Park Boulevard). There are unlit bulbs and trees obstructing lights. The unlit lights are as follows: <ul style="list-style-type: none"> - Double-sided light in median - Two other unlit bulbs (one on each side of Patton near Regent Park) Lighting in parking lots is dark in spots where pedestrians are walking on south side of Patton Shelters are not provided at all bus stop locations 	<p>Near Term</p> <ul style="list-style-type: none"> Pass information along to City and District to identify driveways for relocation, closing, or consolidation (support their review of upcoming driveway permits and redevelopment plans) Opportunity to revise tow truck rotation practice to call nearest available unit Replace unit bulbs Reorient curb ramps as opportunities arise for sidewalk improvements Trim trees to improve visibility of signs and clearance for pedestrians

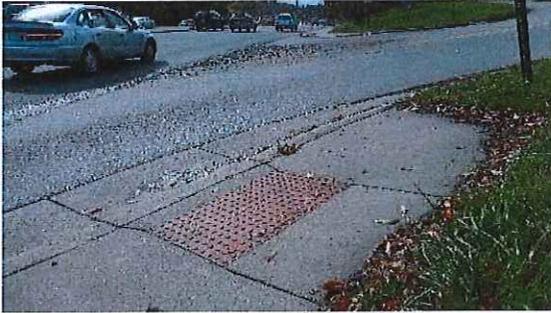
- Curb ramps direct pedestrians into the center of the intersection rather than along the sidewalk/crosswalk

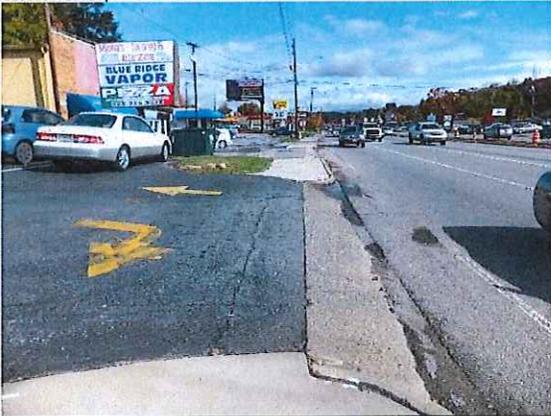
- Trees obstruct signing and hang low creating obstruction for pedestrians
- Sidewalks stop at most driveways rather than continuing sidewalks across driveways, which sends a message of priority to the driver rather than the pedestrian

- Enhance sidewalk network as redevelopment occurs (i.e., sidewalks should continue across driveways rather than driveways continuing across sidewalks)

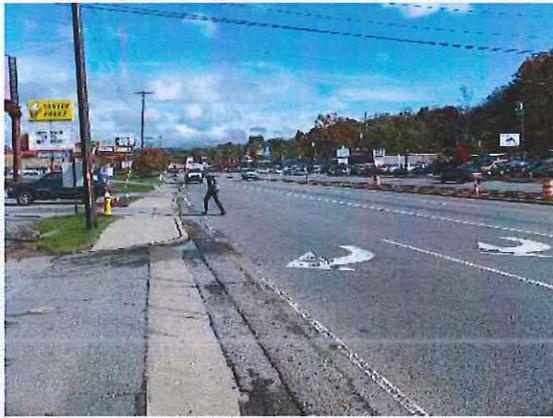
- Several driveways on north side create conflicts with pedestrians, and those within the westbound dual-right turn lane create a weaving movement to enter westbound through lane or U-turn at Leicester.
- Access to Little Caesar's is steep, which is an ADA issue

Patton with priority to closing those within the functional area of the intersection

- Redesign Little Caesar's driveway for ADA compliant cross-slope

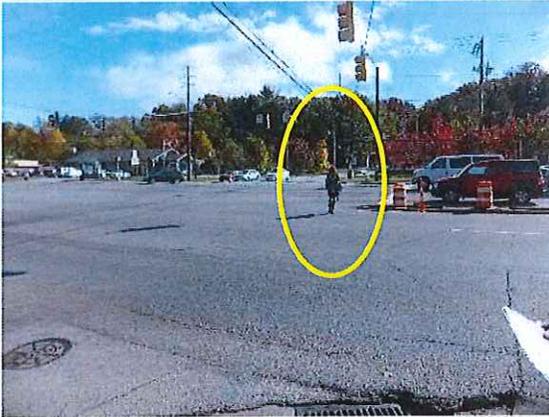
- No crosswalks or pedestrian signals on the west side. Note that the eastbound bus stop is on east side and has access to existing crosswalk.
 - Westbound bus stop is located on west side of the intersection (where crosswalk is missing)
 - Pedestrians observed crossing Patton Avenue on west side (without crosswalk)

- Pedestrian pushbutton pedestal is loose on NE corner (farthest north)
- Bus shelter on north side is obstructing guide signs
- Southbound bus on Louisiana made left turn and immediately stopped on Patton (southeast side)
 - Creates potential to trap vehicles (following bus) in the intersection
- Missing skip marks for southbound dual left turns
- No sidewalks along northeast side of Louisiana
 - No sidewalks through parking lot to K-Mart
 - 5 pedestrians crashes occurred in K-Mart parking lot in 10-year study period
- Hill in front of K-Mart is washing out and nearby driveway has washout

- Consider installation of crosswalk and pedestrian signal on the west approach
- Consider eliminating right-turn lane (or narrowing all lanes) on Louisiana to gain room for sidewalk. Note that it will be difficult to install sidewalk from Patton Avenue to K-Mart due to grade and existing buildings with limited offset to road
- Consider taking a lane of parking stalls in parking lot to install wide (or designated pedestrian area) sidewalk through the parking lot to K-Mart
- Consider moving bus stop on southeast corner further east to eliminate the potential to trap vehicles in the intersection that are following the bus
- Consider installing retaining walk and filling in hole in front of K-Mart
- Reconstruct sidewalk and drainage on the northwest corner

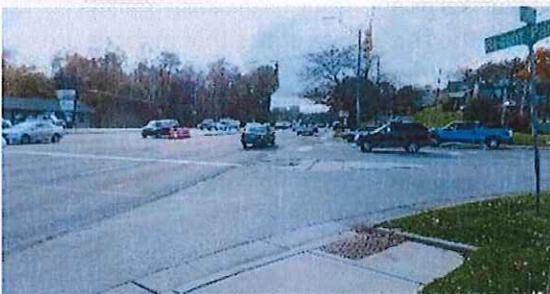
- No crosswalks or pedestrian signals

- Positive: pedestrian refuge islands
 - Issue with height of refuge islands and number of traffic paths pedestrians must cross
- Wide crossing (120 ft or more from curb to curb)
- STOP bar is placed beyond refuge islands
 - Drivers block pedestrians

- Install truncated domes within refuge islands
- Move stop bar back
- Replace grate covers with ADA-compliant grates
- Fix yield sign and add saw tooth pavement markings for yield control

- Install crosswalk for pedestrians crossing Regent Park
- Consider eliminating westbound right-turn slip lane from Patton Avenue to Regent Park
- Consider narrowing the width of Regent Park approach, eliminating the southbound right-turn slip lane or bringing the

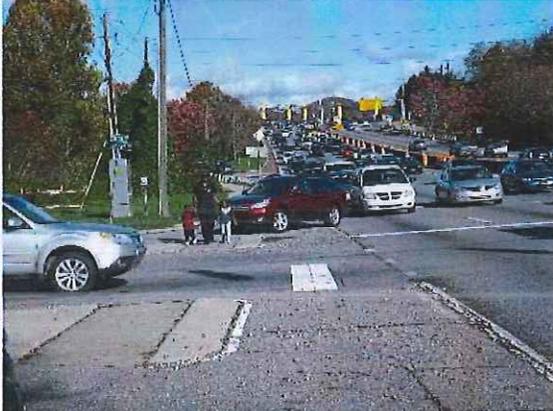
- Left turn drivers block right turn visibility

- Drainage grates have wide spacing of crossbars the run parallel to the travel lane, which are not ADA compliant and present an issue for bicyclists
- Yield sign at southbound approach is bent away from drivers' view
- Short, discontinuous segment of sidewalk along Regent Park
